Manhole Inspection Summary

Manhole # S39W__012MH

Insp Date: **2/26/08 4:06 PM**

Location Address: **rear 1847 covington st.**

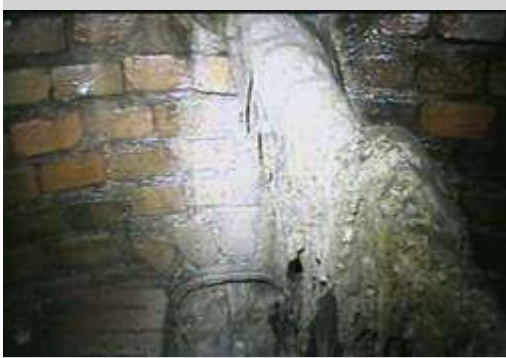
misc

debris clog from pipe in @9

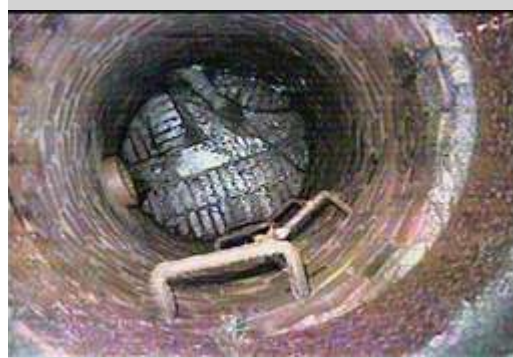
Defect 2

Count: **5** Missing: **0** ☒ **Corroded**

corroded steps

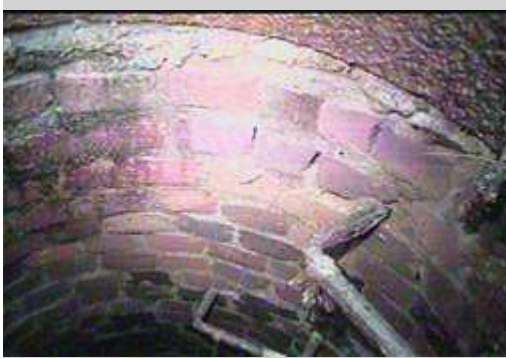
Defect 1

Condition: ☐ Sound ☐ Cracked ☐ Root Intrusion ☐ Loose Brick ☒ **Deteriorated**

chimney deteriorated

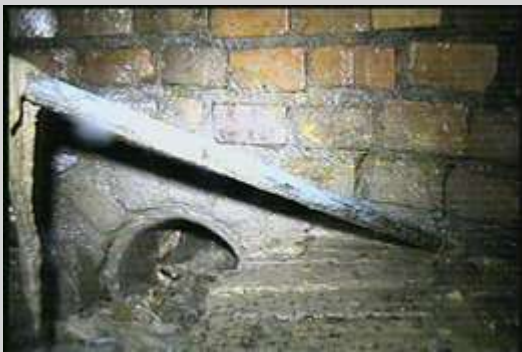
12 O'Clock Outflow

Deposits: ☐ None ☐ Mud ☒ Sludge ☒ Debris ☐ Grease

Silt Depth: 6 (in.) Deposits Extent: Heavy

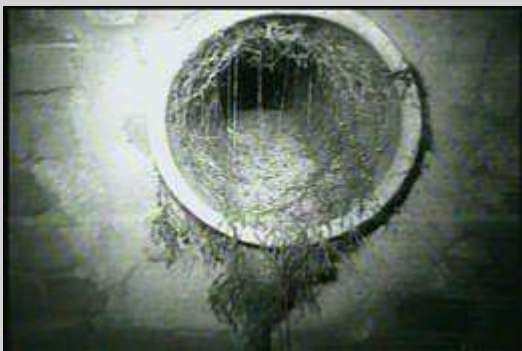
6 O'Clock Inflow

Deposits: ☐ None ☐ Mud ☒ Sludge ☐ Debris ☐ Grease

Silt Depth: 2 (in.) Deposits Extent: Medium

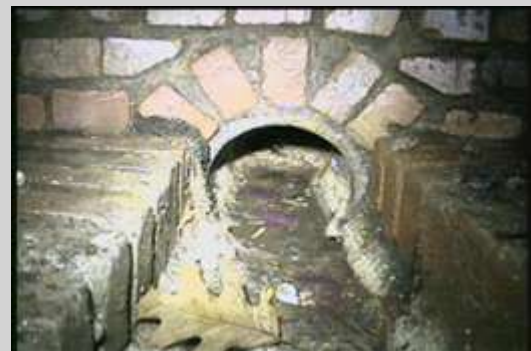
Drop In @ 6 OClock

Drop Condition: Partly Clogged

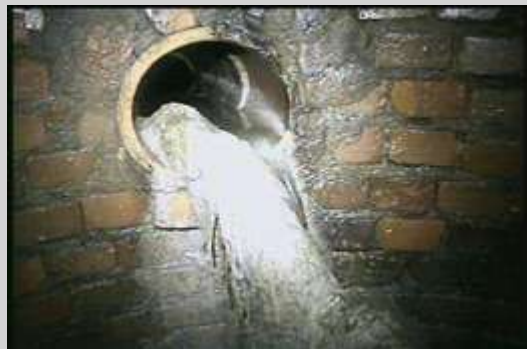
Pipe In @ 9 OClock

Deposits: ☐ None ☐ Mud ☒ Sludge ☒ Debris ☐ Grease

Silt Depth: 8 (in.) Deposits Extent: Heavy

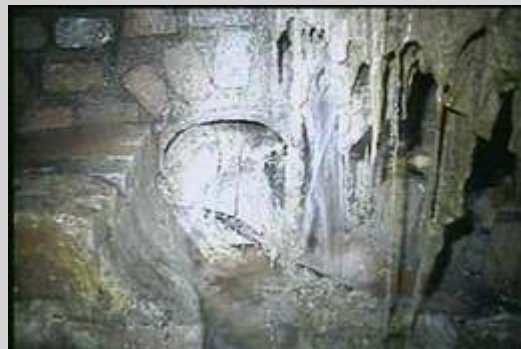
Drop In @ 9 OClock

Drop Condition: Partly Clogged
